Case 281 : Narrative

Case Vehicle (A): 1998 Jaguar	Vehicle (B): 1999 Ford
Type: Vanden Plaus, 4-door sedan	Type: Explorer Sport, 4 x 4, 2-door SUV
Driver: 48-year-old female	Driver: 69-year-old male
CDC: 12-FYEW-1	CDC: 99-0000-0

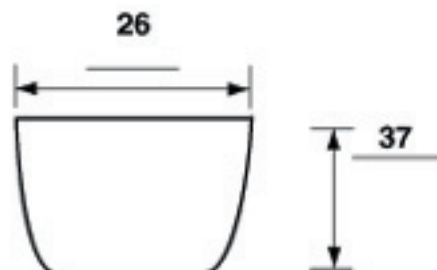
Driver Airbag Doors

Single Door

Vents: ☒ Y ☐ N
if yes, how many: 2
at 1 and 11 o'clock

Tethers: ☒ Y ☐ N
if yes, how many: 2
